# Historic American Timber Joinery: A Graphic Guide | 2004-08

# HISTORIC AMERICAN TIMBER JOINERY

A Graphic Guide

By Jack A. Sobon

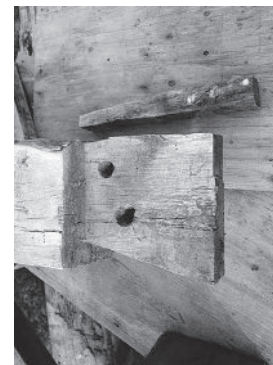
*The Through Mortise and Tenon with Dovetailed Shoulder (Figs. 11 and 12). A local (Columbia County, New York) variation of the wedged dovetail joint has the dovetail on the tenon continue into the housing which, because of the flare of the post, is about 3 in. deep. Only two buildings have been found with this joint. Judging by their location and similarities, they are likely the work of the same builder. The drawback to this joint would be the potential for the tie beam to fail in shear where it is notched to fit the housing. Apparently the load on the joint in this 28-ft.-wide barn is matched by the heavy oak tie beam, for nothing has failed in over 200 years.*

*Figs. 11 and 12. Below and below right, assembled and exploded views of a wedged dovetail through mortise and tenon with dovetailed housing, as found in a 28x34 three-bay side-entrance barn in East Chatham, New York, probably dating from the second half of the 18th century. This unique joint has exceptional tensile strength.*

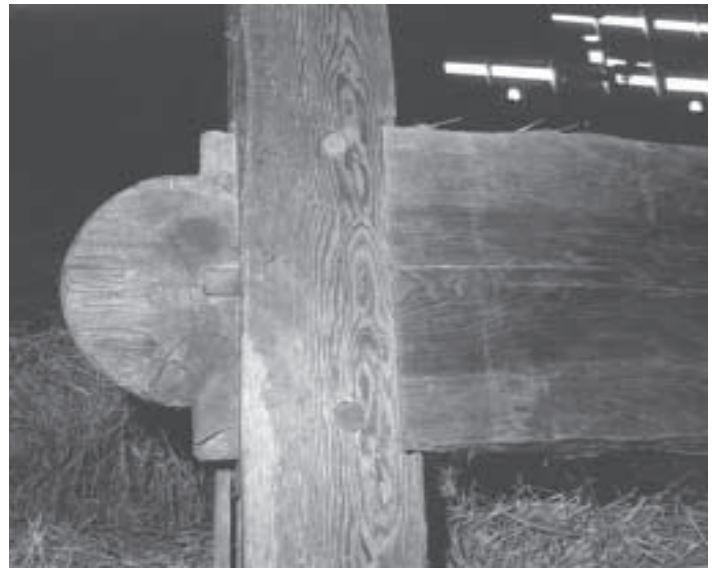
*This unusual tenon profile appears on three Dutch barns in Coeymans, N.Y., likely the signature of a particular builder.*

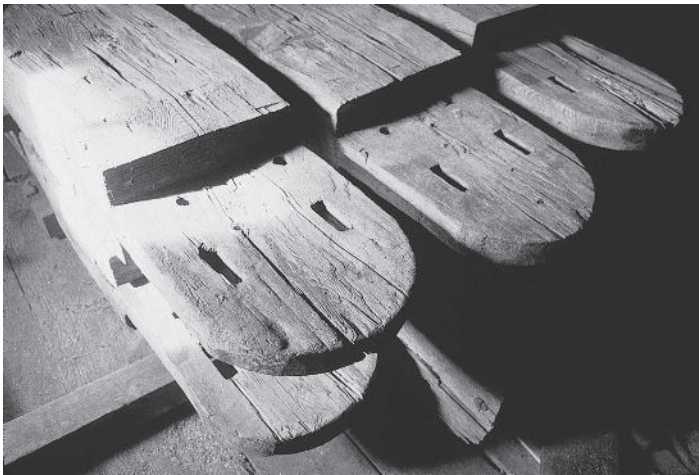
Anchorbeam tenon ends from a pre-1820 Dutch barn taken down in Altamont, New York.

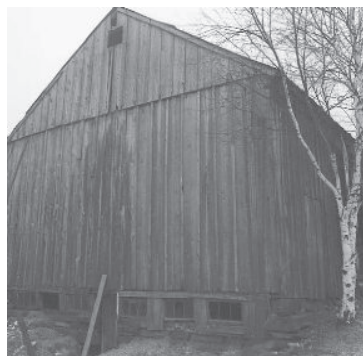
*Boarding lapped at tie beam.*

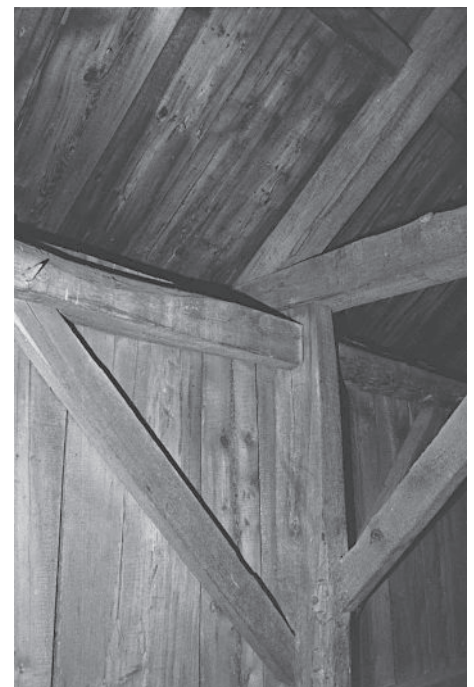
*English tying joint tradition lives on after a fashion, with dropped, interrupted plates, in this Newfields, Maine, aisled barn. The plates tenon into the sides of the post; a flying plate (not visible) is supported by the tie beam ends.*

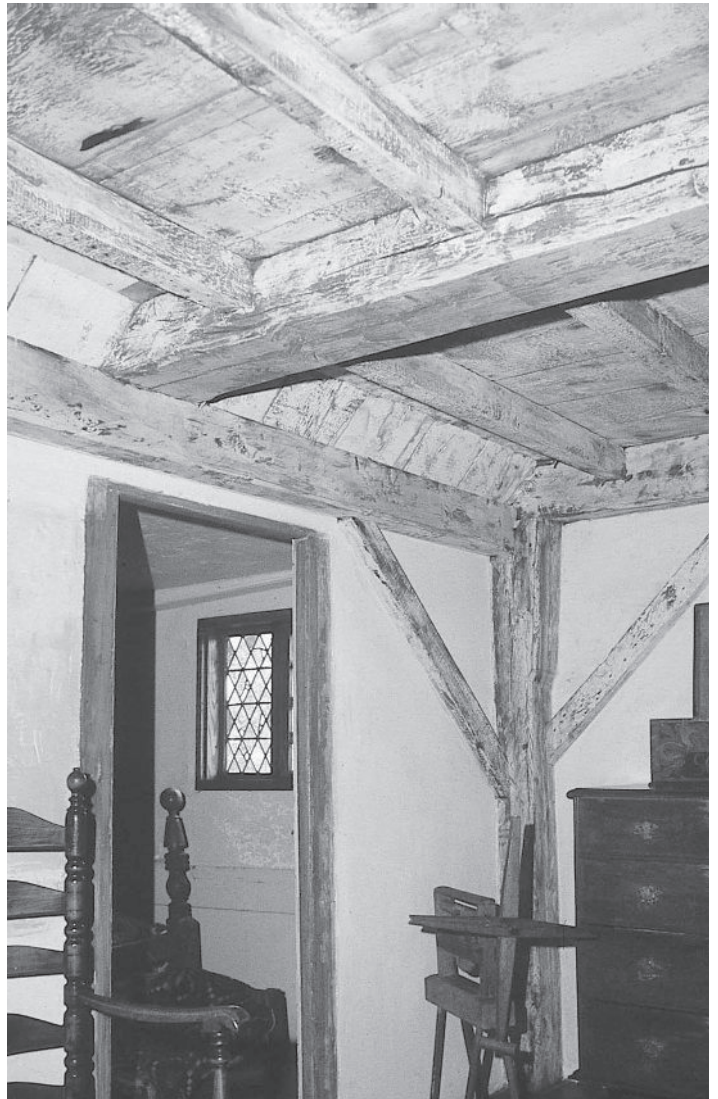
*At right, interior view of the Howland House, a 17th-century dwelling in Plymouth, Massachusetts, showing the awkward bit of roof visible above the plate in the normal configuration of the English tying joint (see Figs. 2 and 3). Here the summer beam bears on the plate; it was more common in such houses for the summer to span between the ties, and thus for common joists to bear on the plates.*

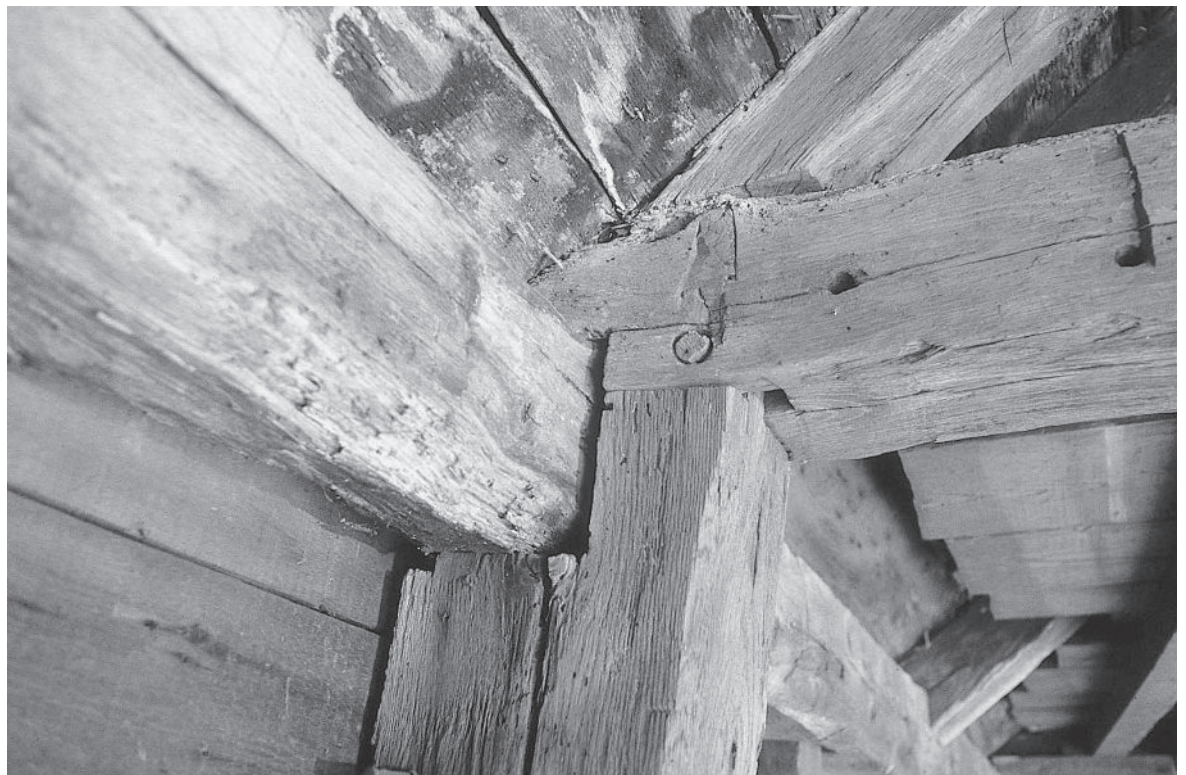
*Below, another typical (if not very well cut) English tying joint, from a 1750s blacksmith shop in Sherborn, Massachusetts. See Figs. 2 and 3 of this chapter.*

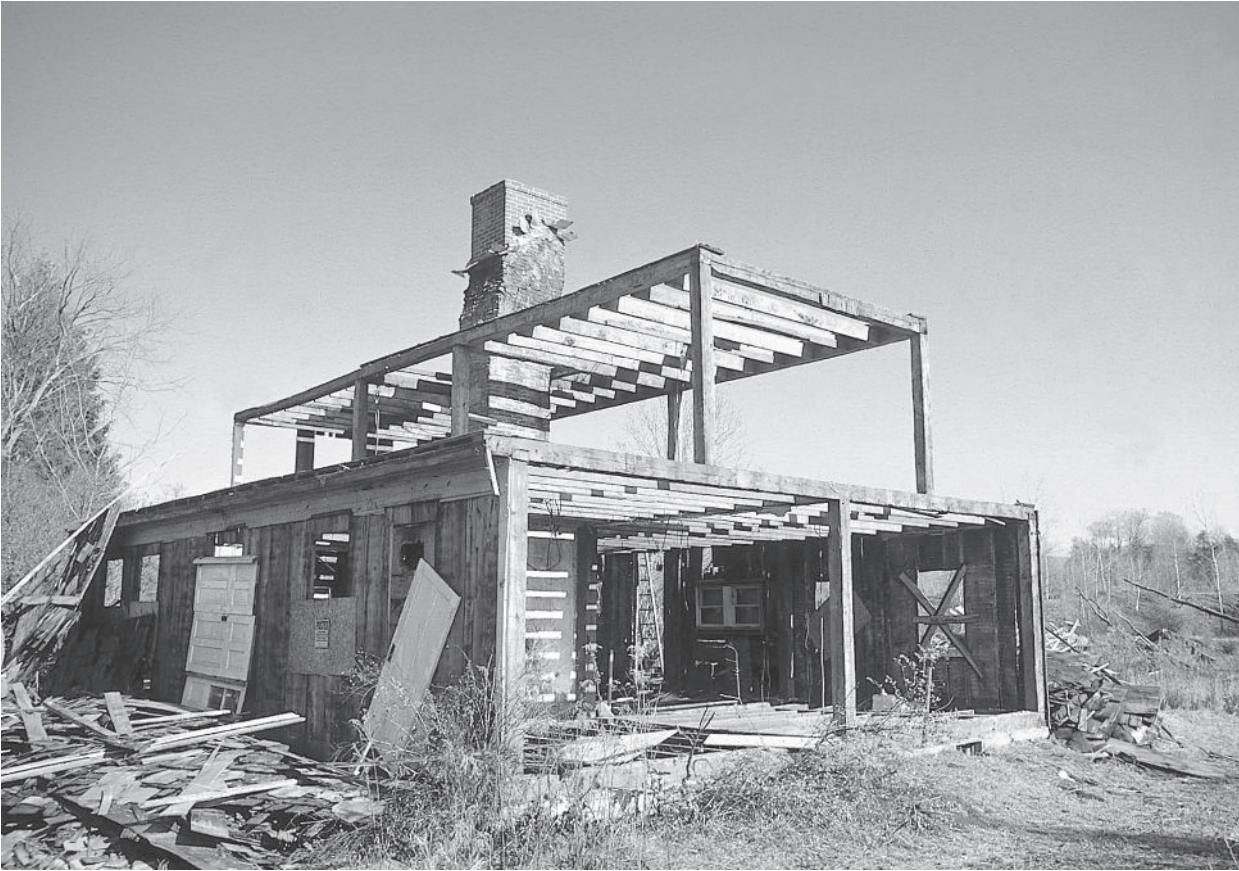
*Above, flush tying joints, with top of tie beam and top of plate coplanar, yield neat box frames, as seen in this partly dismantled 1791 house in Cheshire, Massachusetts (see Figs. 11 and 12 of this chapter). Below, mid-18th-century aisled barn in Kensington, New Hampshire, with English tying joint and rare extended tie beams that cross the main, continuous plate and carry the members of an interrupted flying plate tenoned between them. The flying plate, seen to the right of the peg, supports a Greek Revival cornice.*

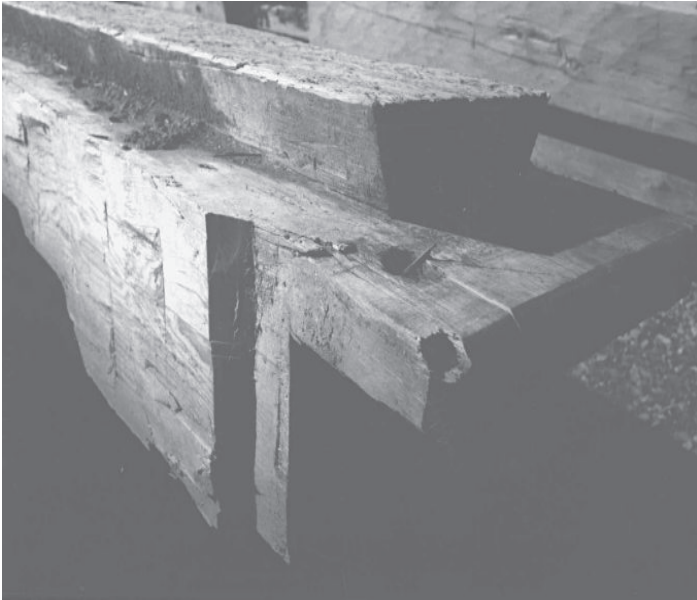
Sixty-ft. 14x17 hemlock sill girder from a barn in Middleburg, N.Y., rabbeted and undercut on both sides for 3-in. threshing-floor planks. Girder was blind-tenoned to gable sill and secured by three pins.

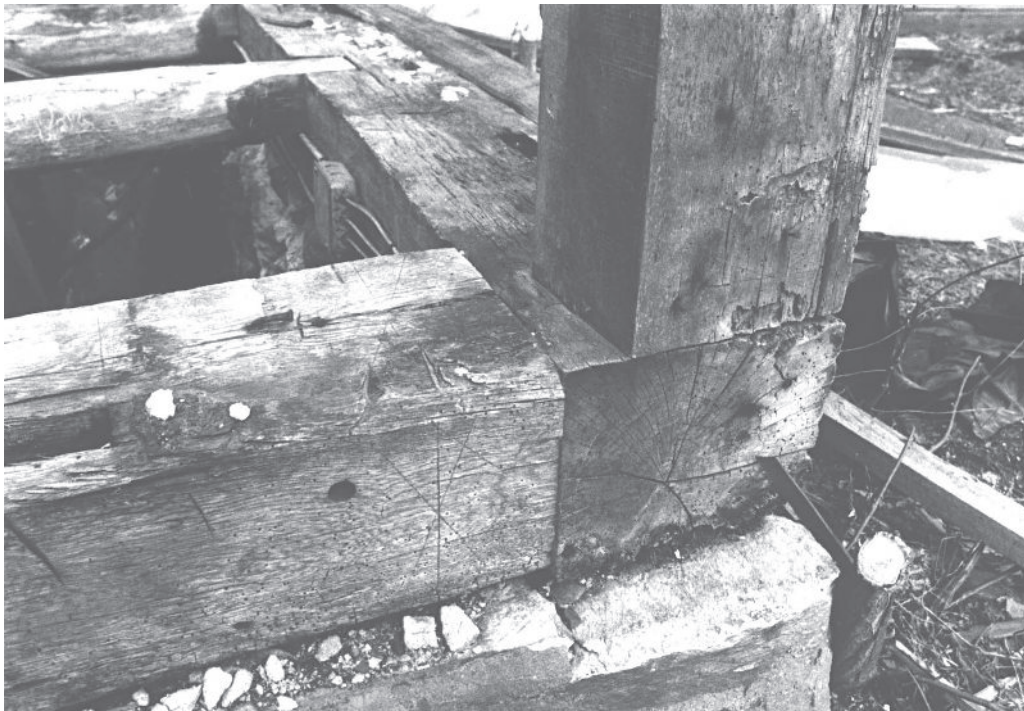
The typical blind sill corner joints on this house frame in Charlemont, Massachusetts, give little clue to their inner mortise and tenon configuration. The first joist to the rear, hewn flat only where necessary, joins the sill in a butt cog. Timber sills and girders, historically a natural part of the timber frame, have virtually disappeared from modern American work.

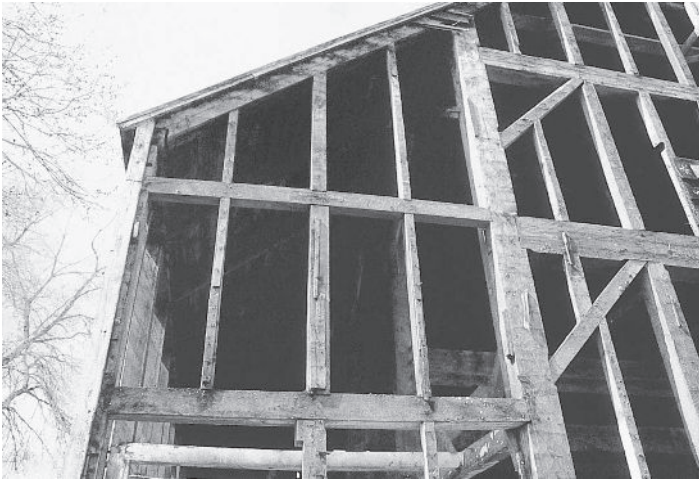
*Sheathing direction determines the orientation of wall framing. This early-1800s barn (now dismantled) from Middleburg, N.Y., has studs to support wide clapboards. Note how braces take precedence over the studs.*

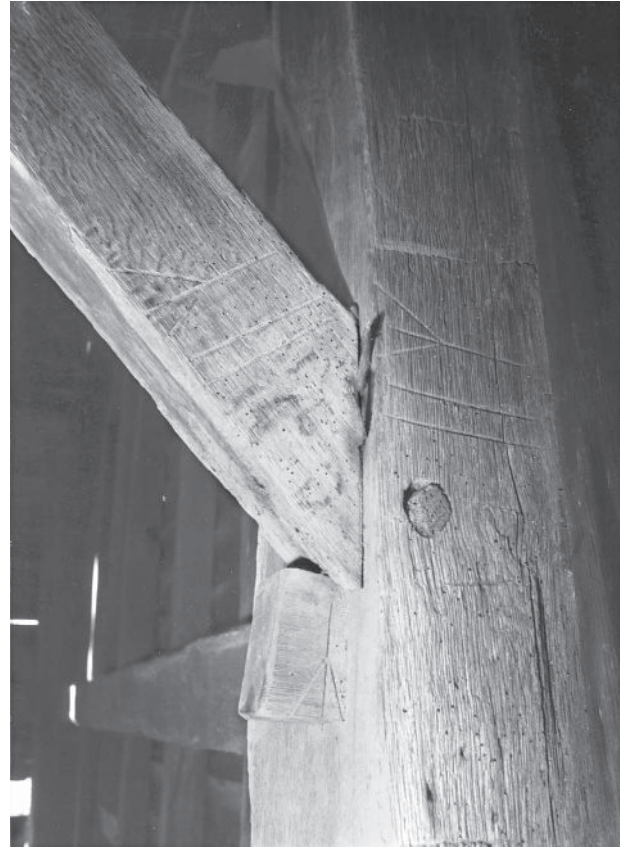
*Scribe rule barn in Chatham, N.Y., with packing or distance piece driven to take up space needed to fit brace into made-up assembly of post and beam. Brace, post and packing piece are all marked for reassembly after scribing.*

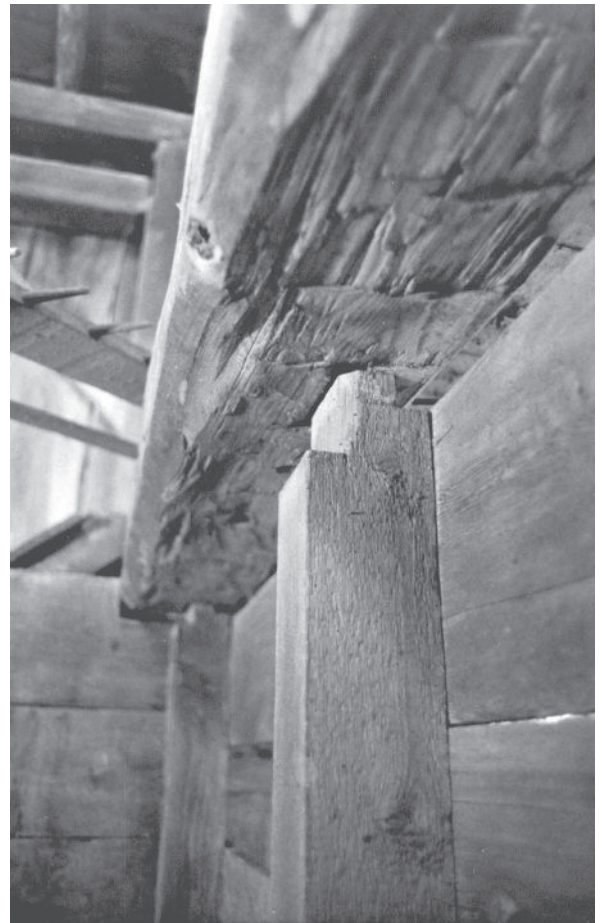
*This partially withdrawn stud in a barn in Shaftsbury, Vermont, was relieved at its end to make its tenon barefaced. The relief cut was not angled as usual, and gives the appearance of a second cheek and shoulder.*

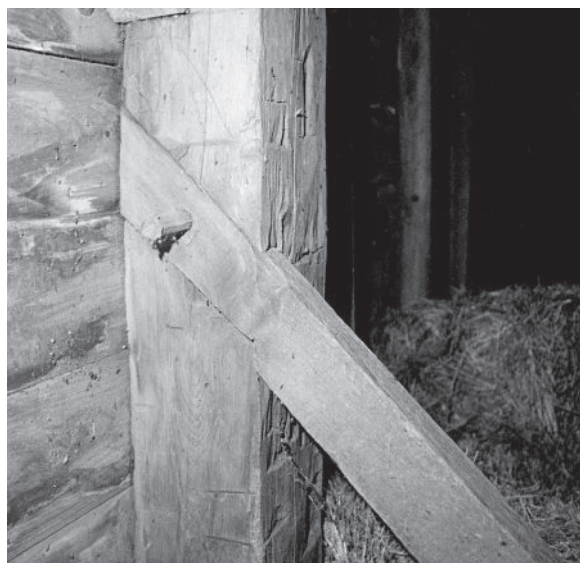
Through-lapped half-dovetails are common. The through housing removes more wood from the post than a stopped housing but can be sawn to full depth, saving considerable chiseling work. The dovetail slope is typically cut on the inner (here lower) edge of the brace. This brace runs from a post down to a tie beam in a scribe rule German barn dismantled in Alcove, N. Y., and moved to Long Island.

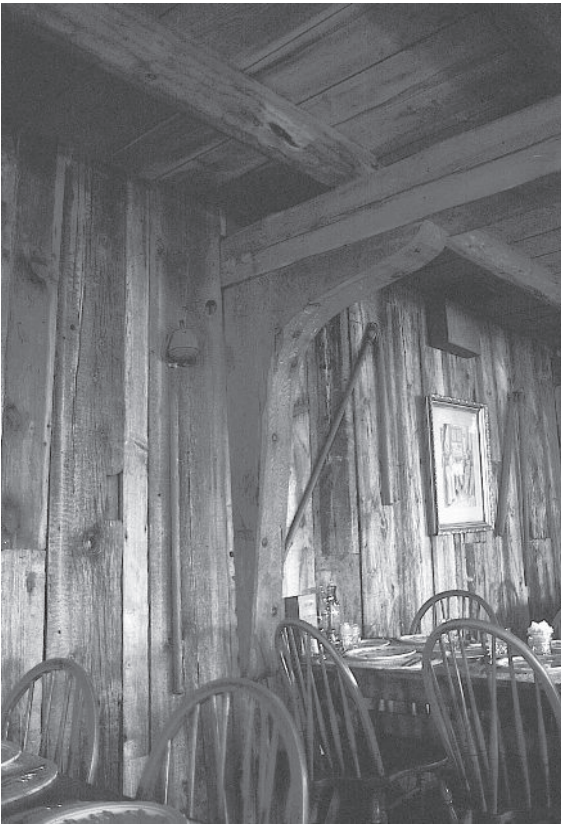
To conserve headroom, knees were used in buildings as well as ships. Cut from naturally curved, tough root-trunk or trunk-branch portions of the tree, they were pinned or bolted to the post and crossbeam. This one stiffens a Kennebunkport, Maine, gristmill and restaurant.

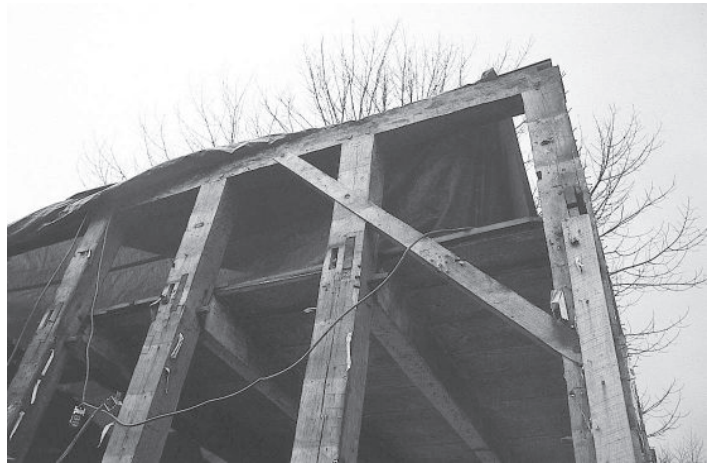
In Dutch houses with closely spaced wall posts, builders might use passing braces to achieve a long (and so more effective) brace length. In this house undergoing renovations in Alford, Massachusetts, the brace passes one post where it is lapped its full thickness and secured with a pin. Below, in lieu of normal braces, some German carpenters would angle a stud to serve as both brace and stud, as in this structure in Ephrata, Pa.

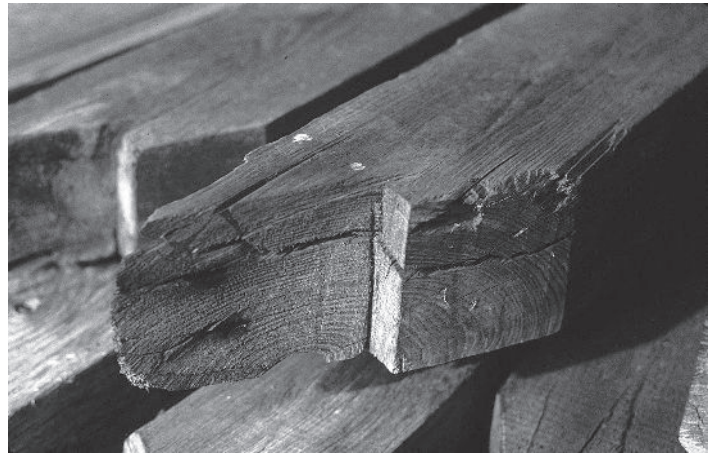
Rafters from a Great Barrington, Massachusetts, carriage shed showing a housed birdsmouth. This joint could be completely sawn.

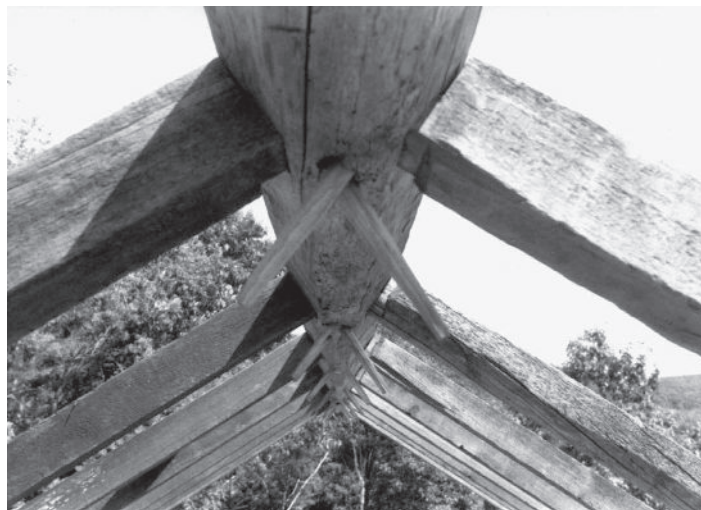
View down the ridge beam of a mid-19th-century 40x50 barn in Hinsdale, Massachusetts. The 3x4 rafters have barefaced tenons.

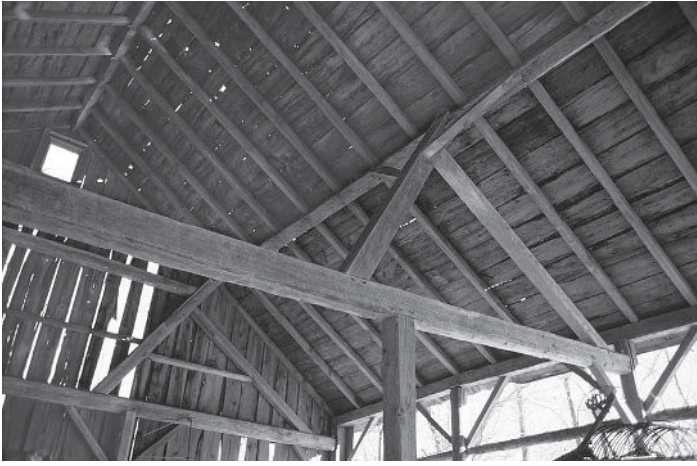
Mid-19th-century Hinsdale, Massachusetts, barn before dismantling. The continuous purlin plate assembly is canted perpendicular to the roof, and the purlin plate is flush with the roof. The rafters tenon into both upper and lower faces of the purlin plate.

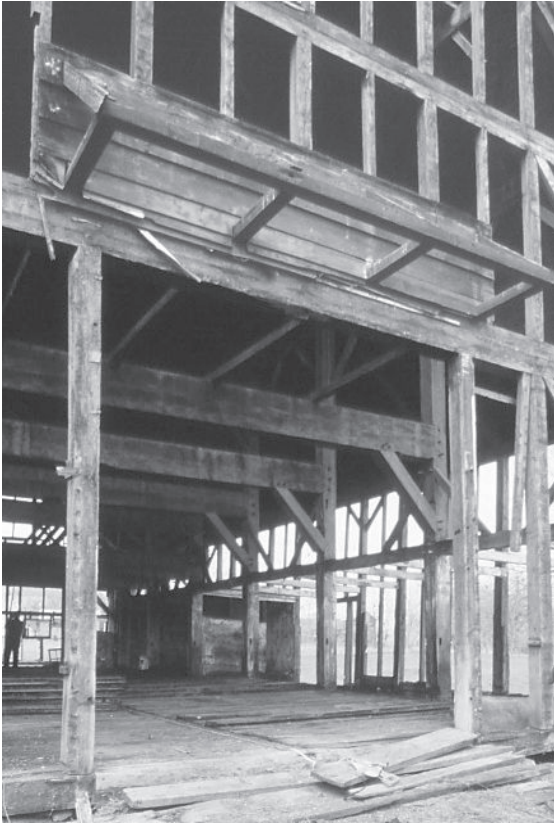
*Cantilevered pentice arms run over the end anchorbeam of this Dutch barn formerly in Middleburgh, New York, and support the pentice plate with blind tenons. Rafters are butted and nailed as in Fig. 40.*

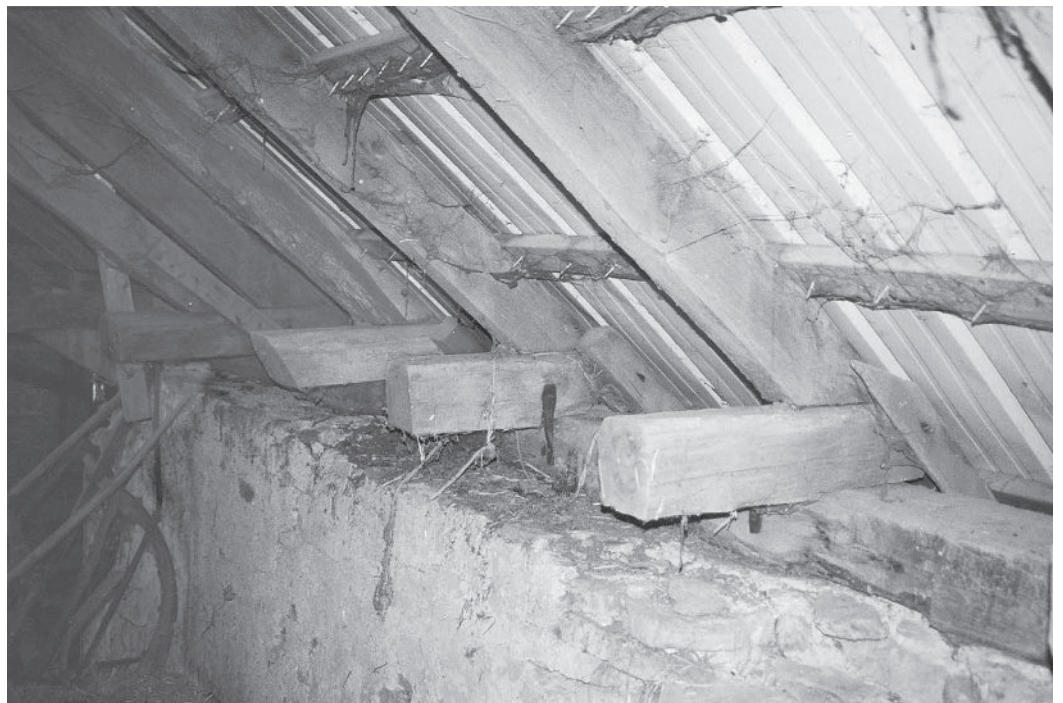
*Principal rafter-common purlin roof frame over the ell of an 1840s house in Windsor, Massachusetts, now dismantled. Purlins are continuous over two bays at each end; central bay purlins are staggered on rafters for sufficient bearing at the connections. (Something went awry at the second rafter from the far end.) Instead of ridge purlins or a continuous ridge beam, purlin-runs closely flank the ridge, leaving rafter joints undisturbed at the peak.*

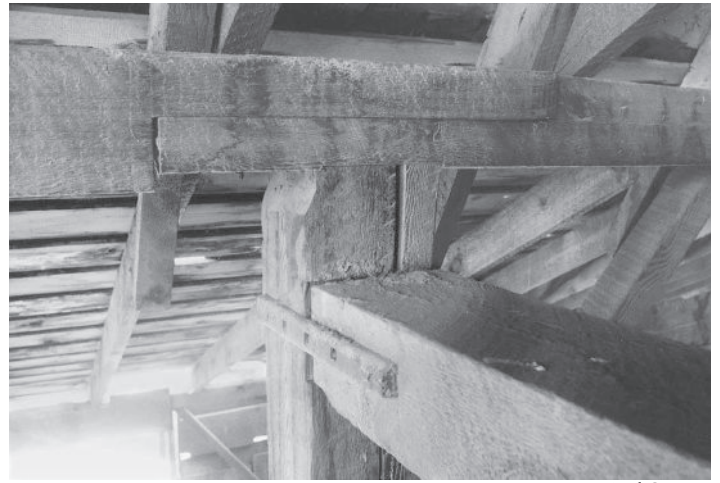
*Simple halved and bolted scarf ca. 1900 near Pullman, Washington.* Paul Oatman

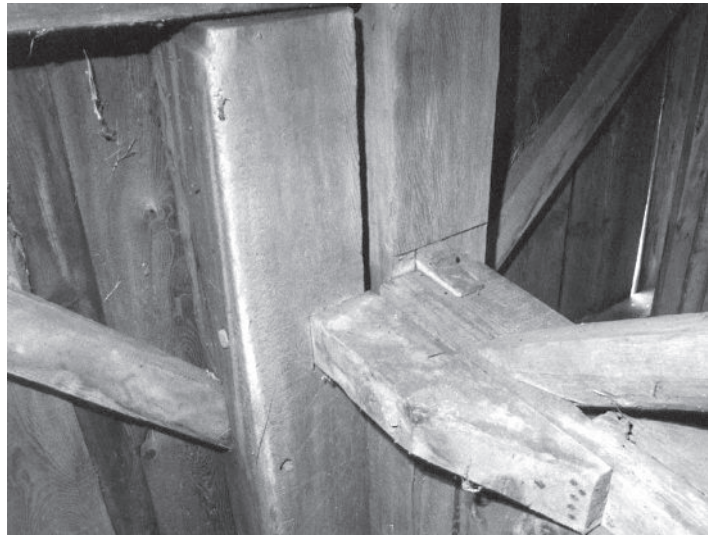
*When the builder added to this barn in Savoy, Mass., he saved on a new 30-ft. tie beam by framing a piece into the post and pinning and nailing it to the existing barn's tie beam. Sheathing remains in place below tie beam; shallow wedge for dovetail tenon emerges on surface.*

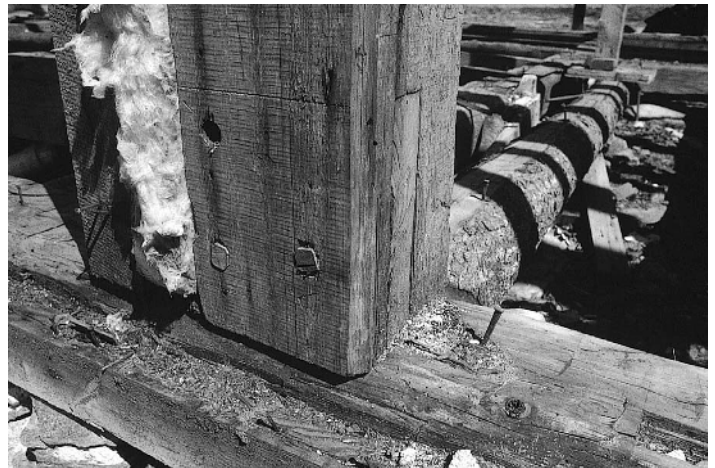
*A free tenon in the bottom of a post in this house in Windsor, Mass., may be a repair or a fix for a mistake. Shadows are cast by joists above.*

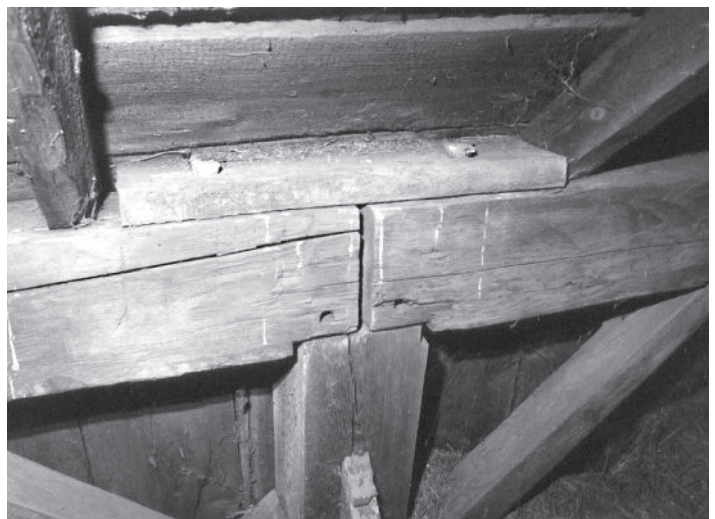
*This strange arrangement in a barn in Rochester, Vermont, uses the post-top tenon as a sort of free tenon to join the plates, though pins are invisible. The builder must have realized the inherent weakness of the connection and added the fish plate on top, secured with two pins.*

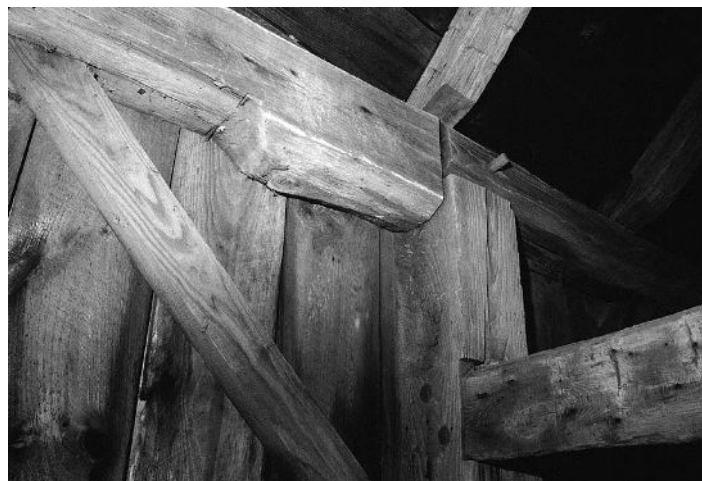
Jowled plate (one of six!) in a much-expanded 18th-century English-style barn, Huntington, Massachusetts.

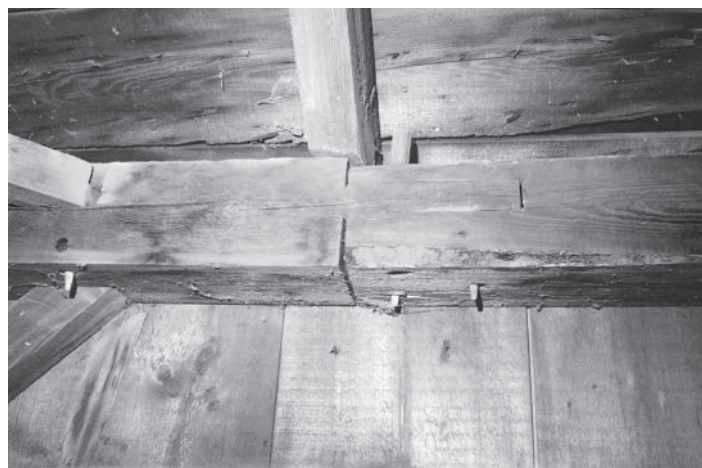
Simple bridled scarf in wall plate of five-bay barn 40 x 60 in Littleton, Massachusetts, built 1850-1870. The 2-in. tenon, 12 in. long, is secured by three pins. The builder used the same joint in the purlin plates.

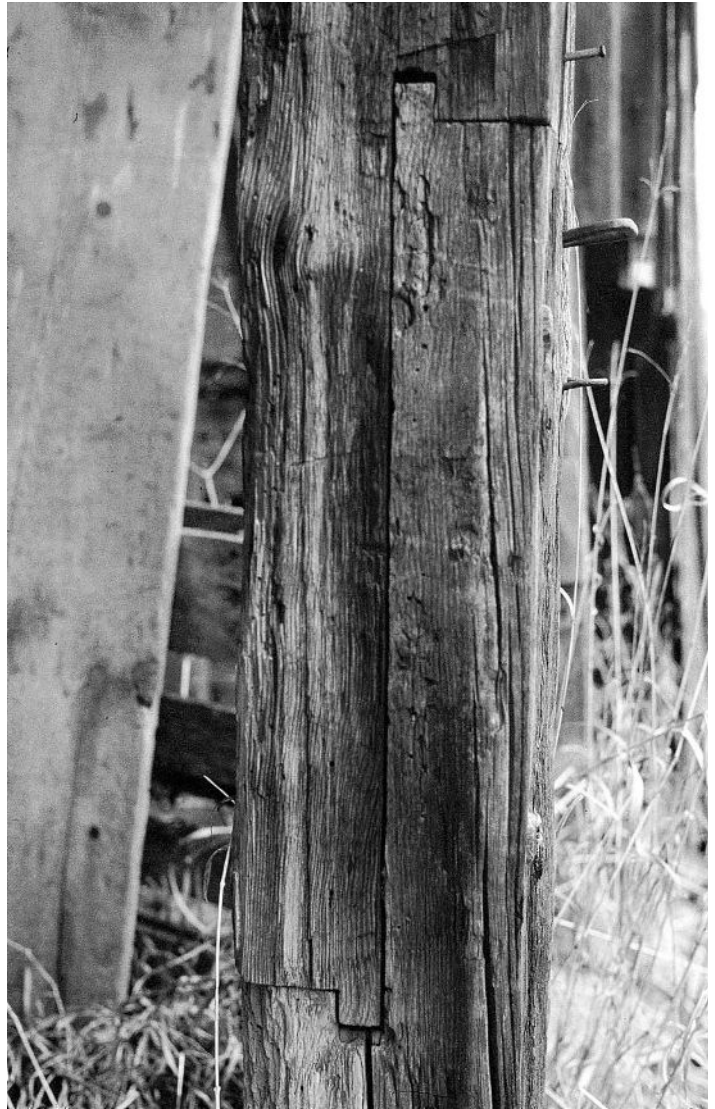
At top, bladed scarf with key, barn sill in Woodford, Calif. The sill is 8x8 Ponderosa pine, the scarf only 16 in. long. Top right, a bladed scarf used to repair a 7½ x 9½ post in a barn in Buskirk, N.Y. The tenons are 1 in. thick and 1 in. long, the scarf 23 in. long, with four pins. Above, a stop-splayed, undersquinted and tabled scarf with key used in a 6½ x 13 truss chord in the 1796 Cabildo in New Orleans (roof burned 1988, reconstructed 1992). There is barely a splay, and two forged iron straps still hold the joint together. At right, this unusual stop-splayed, undersquinted and tabled scarf in Pine Plains, New York, did not employ a key: the halves had to be slid together sideways.
